DEBRIS/ICE/TPS ASSESSMENT  
AND  
PHOTOGRAPHIC ANALYSIS  
OF  
SHUTTLE MISSION STS-32R

January 9, 1990

Gregory N. Katnik  
NASA/Kennedy Space Center  
TV-MSD-22

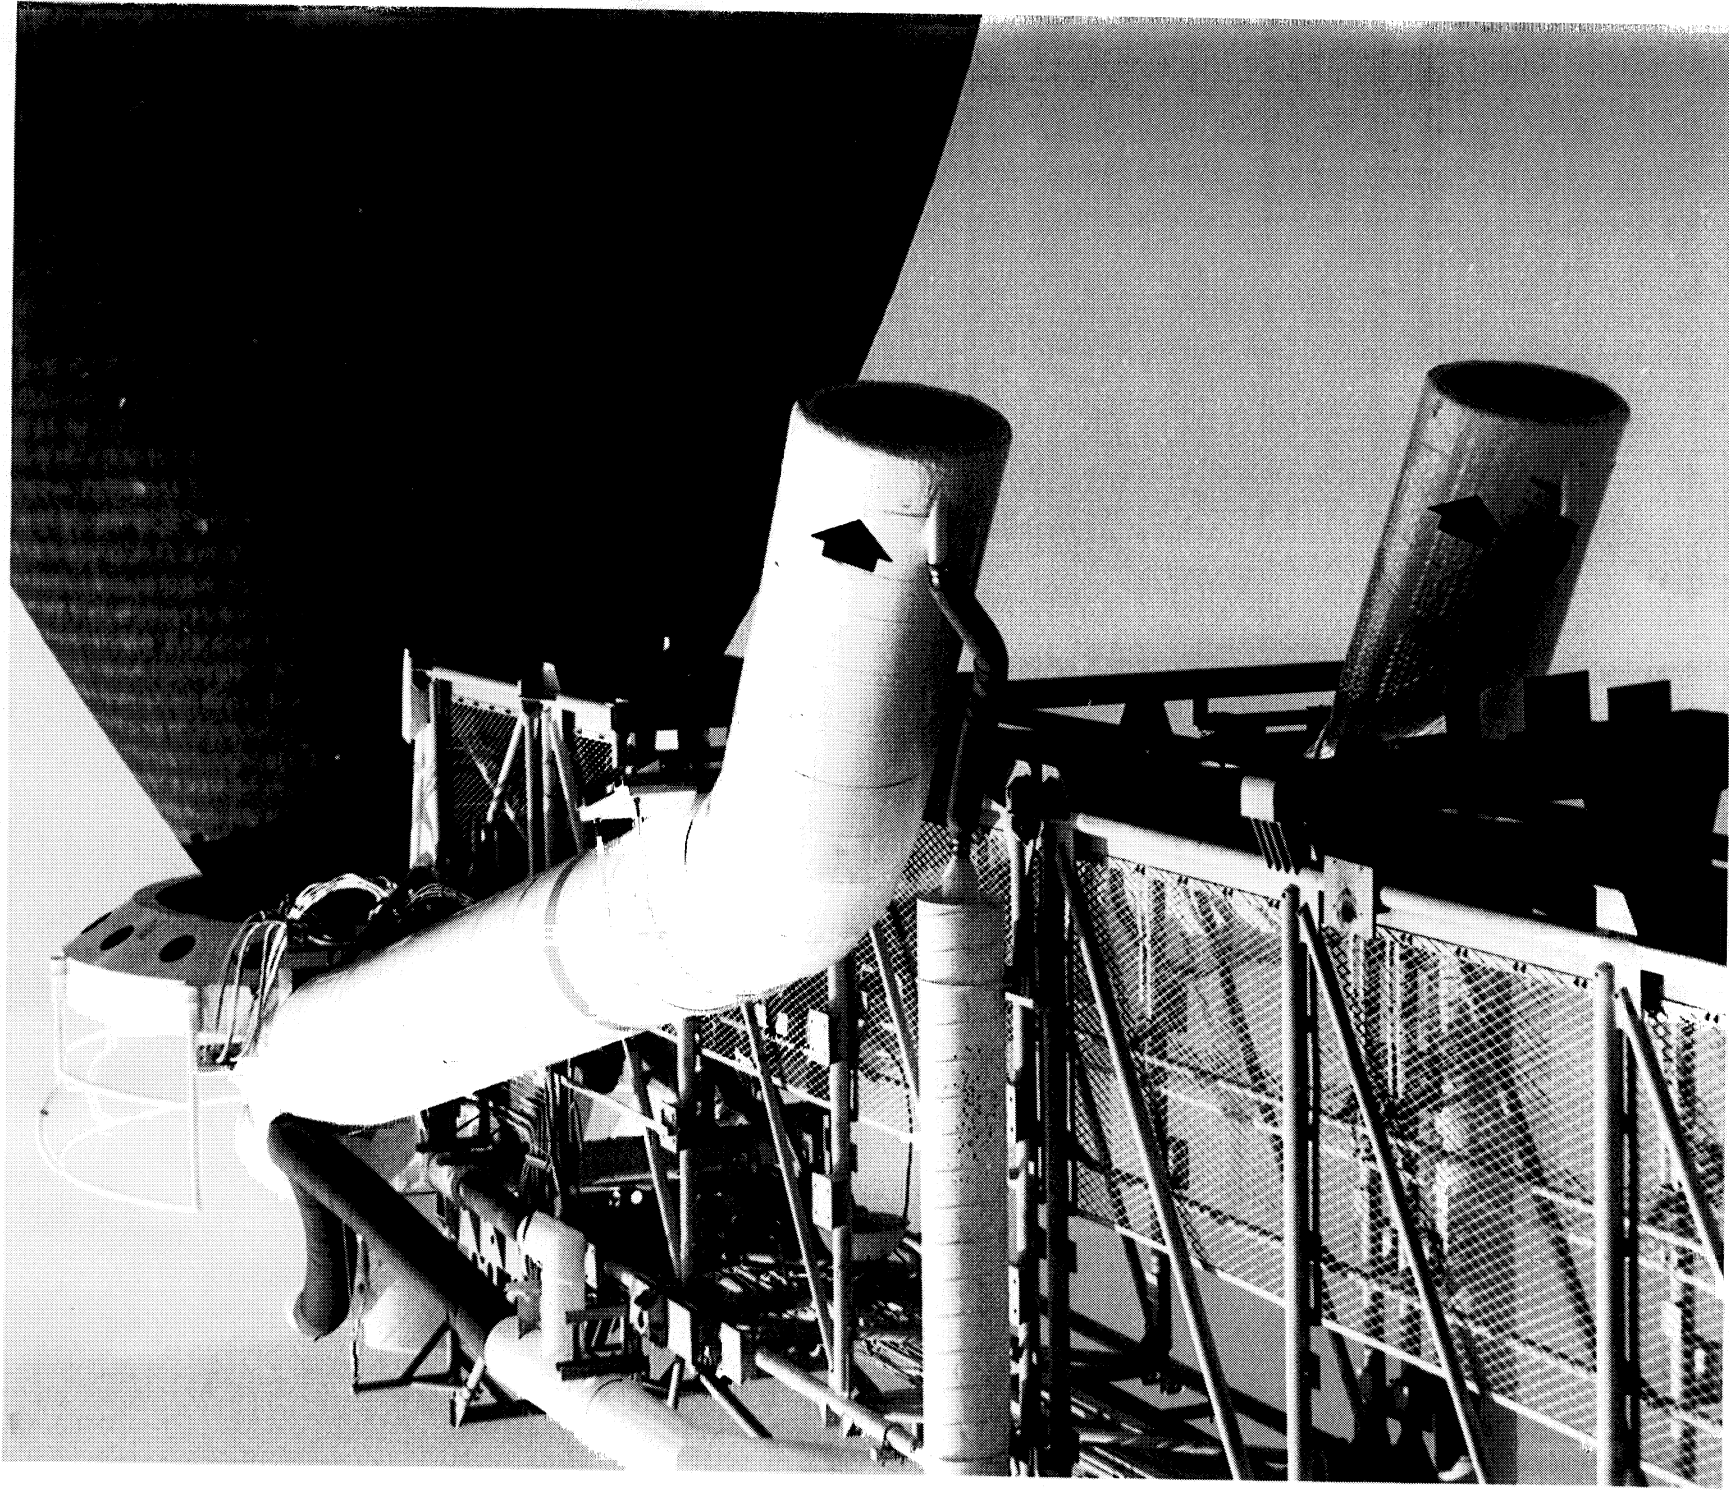
Absence of hydro diverster, which had not been installed on the  
GOX vent ducts, eventually caused the formation of icicles.

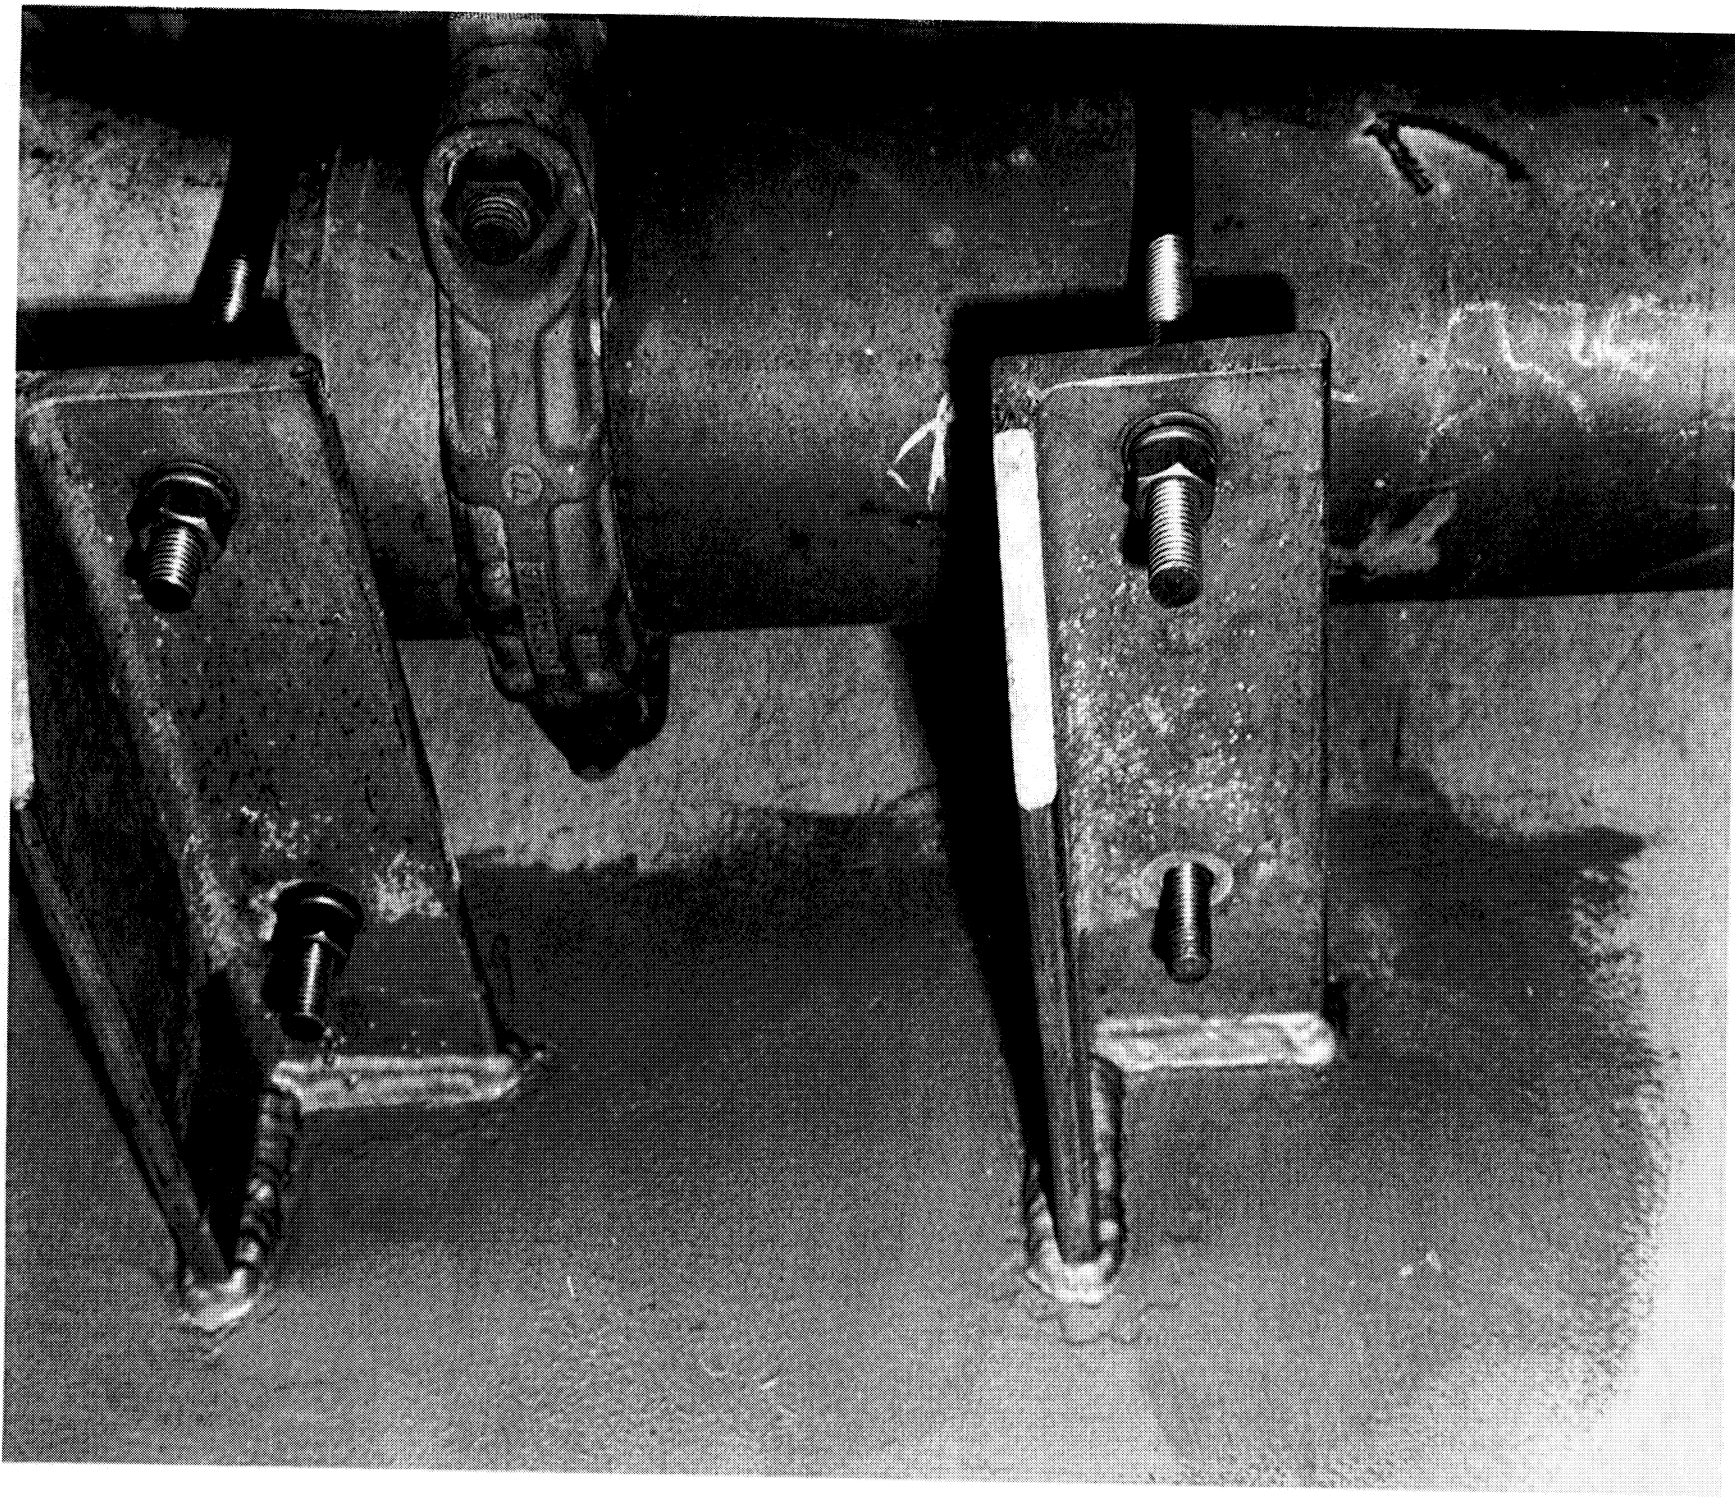
A U-bolt on the sound suppression pipe near the SSME exhaust  
hole was missing a nut and washer

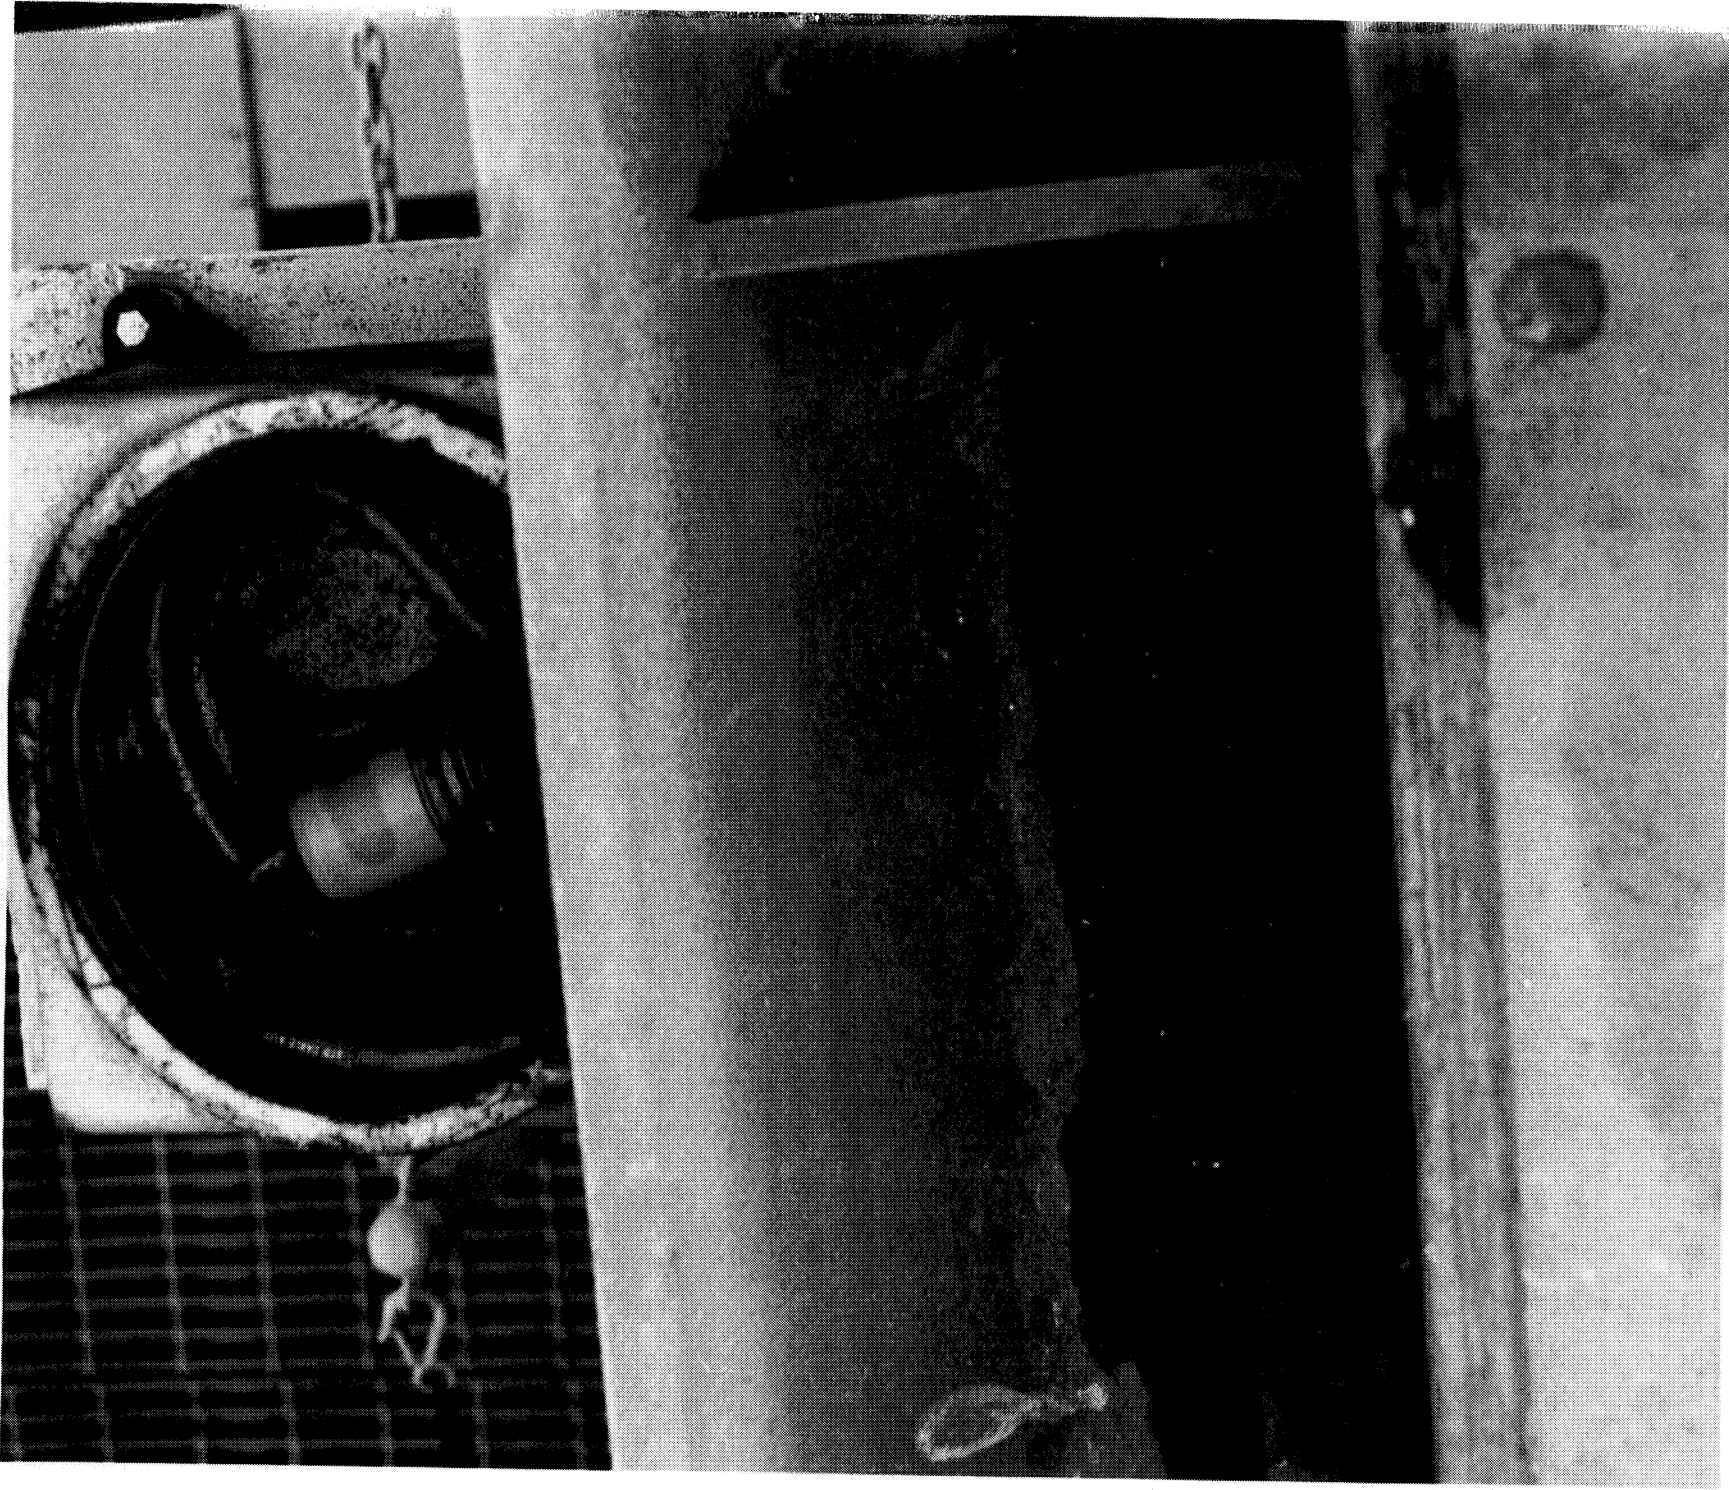
A cover was missing from the electrical box on the MLP NW side

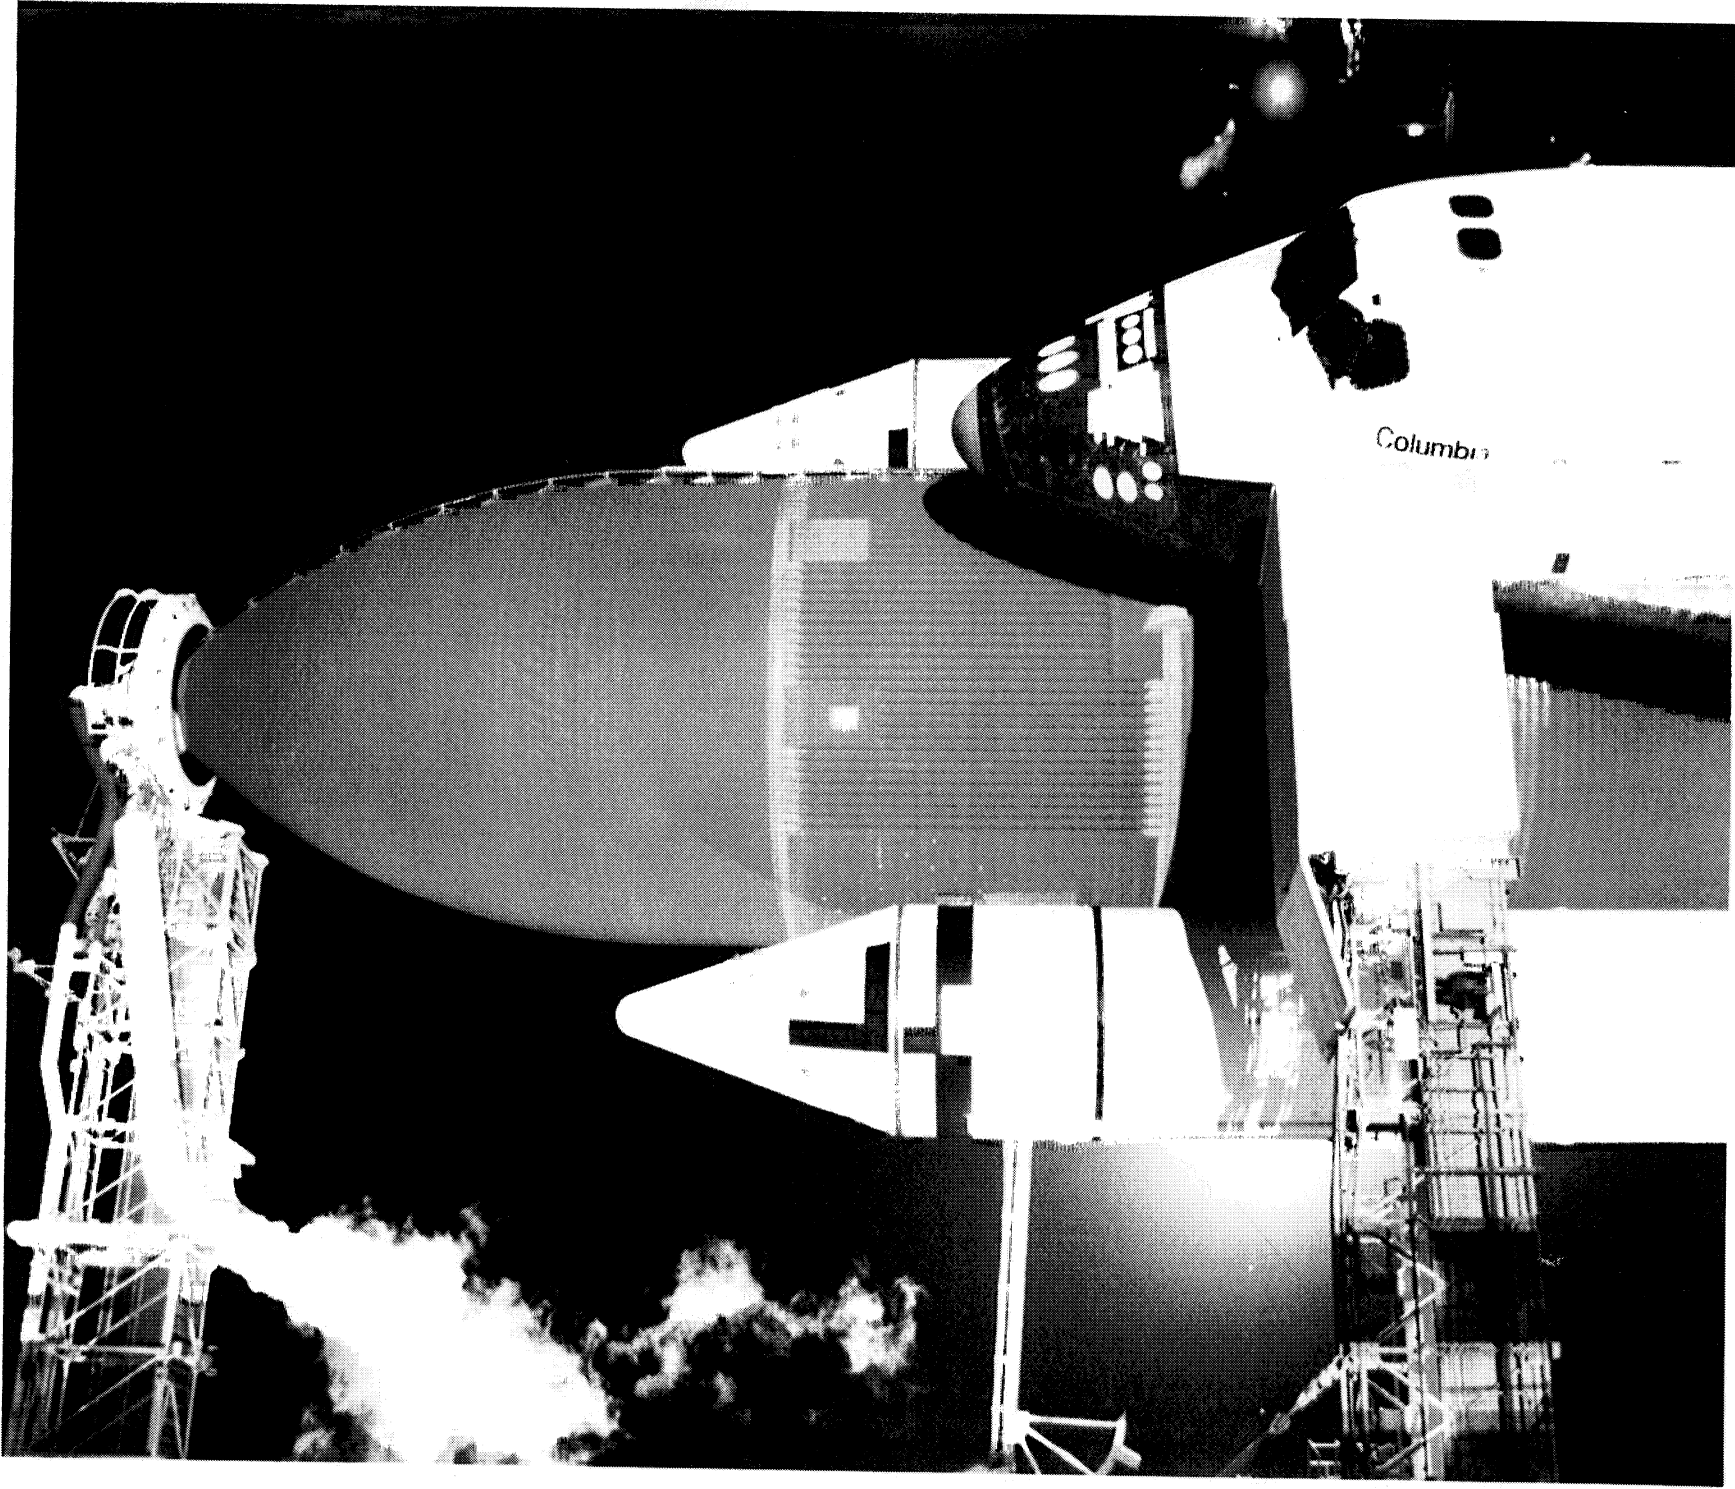
Icicles had begun to form on the ends of the GOX vent ducts during the ice/frost inspection. The icicles formed because the water diverters had not been installed on the vent pipes during the pad modification period. Four icicles, the largest measuring 8 inches long by 1 inch in diameter, were removed by the Ice Team using the specially designed retrieval net. A PR was initiated to install the water diverters prior to the next launch attempt.

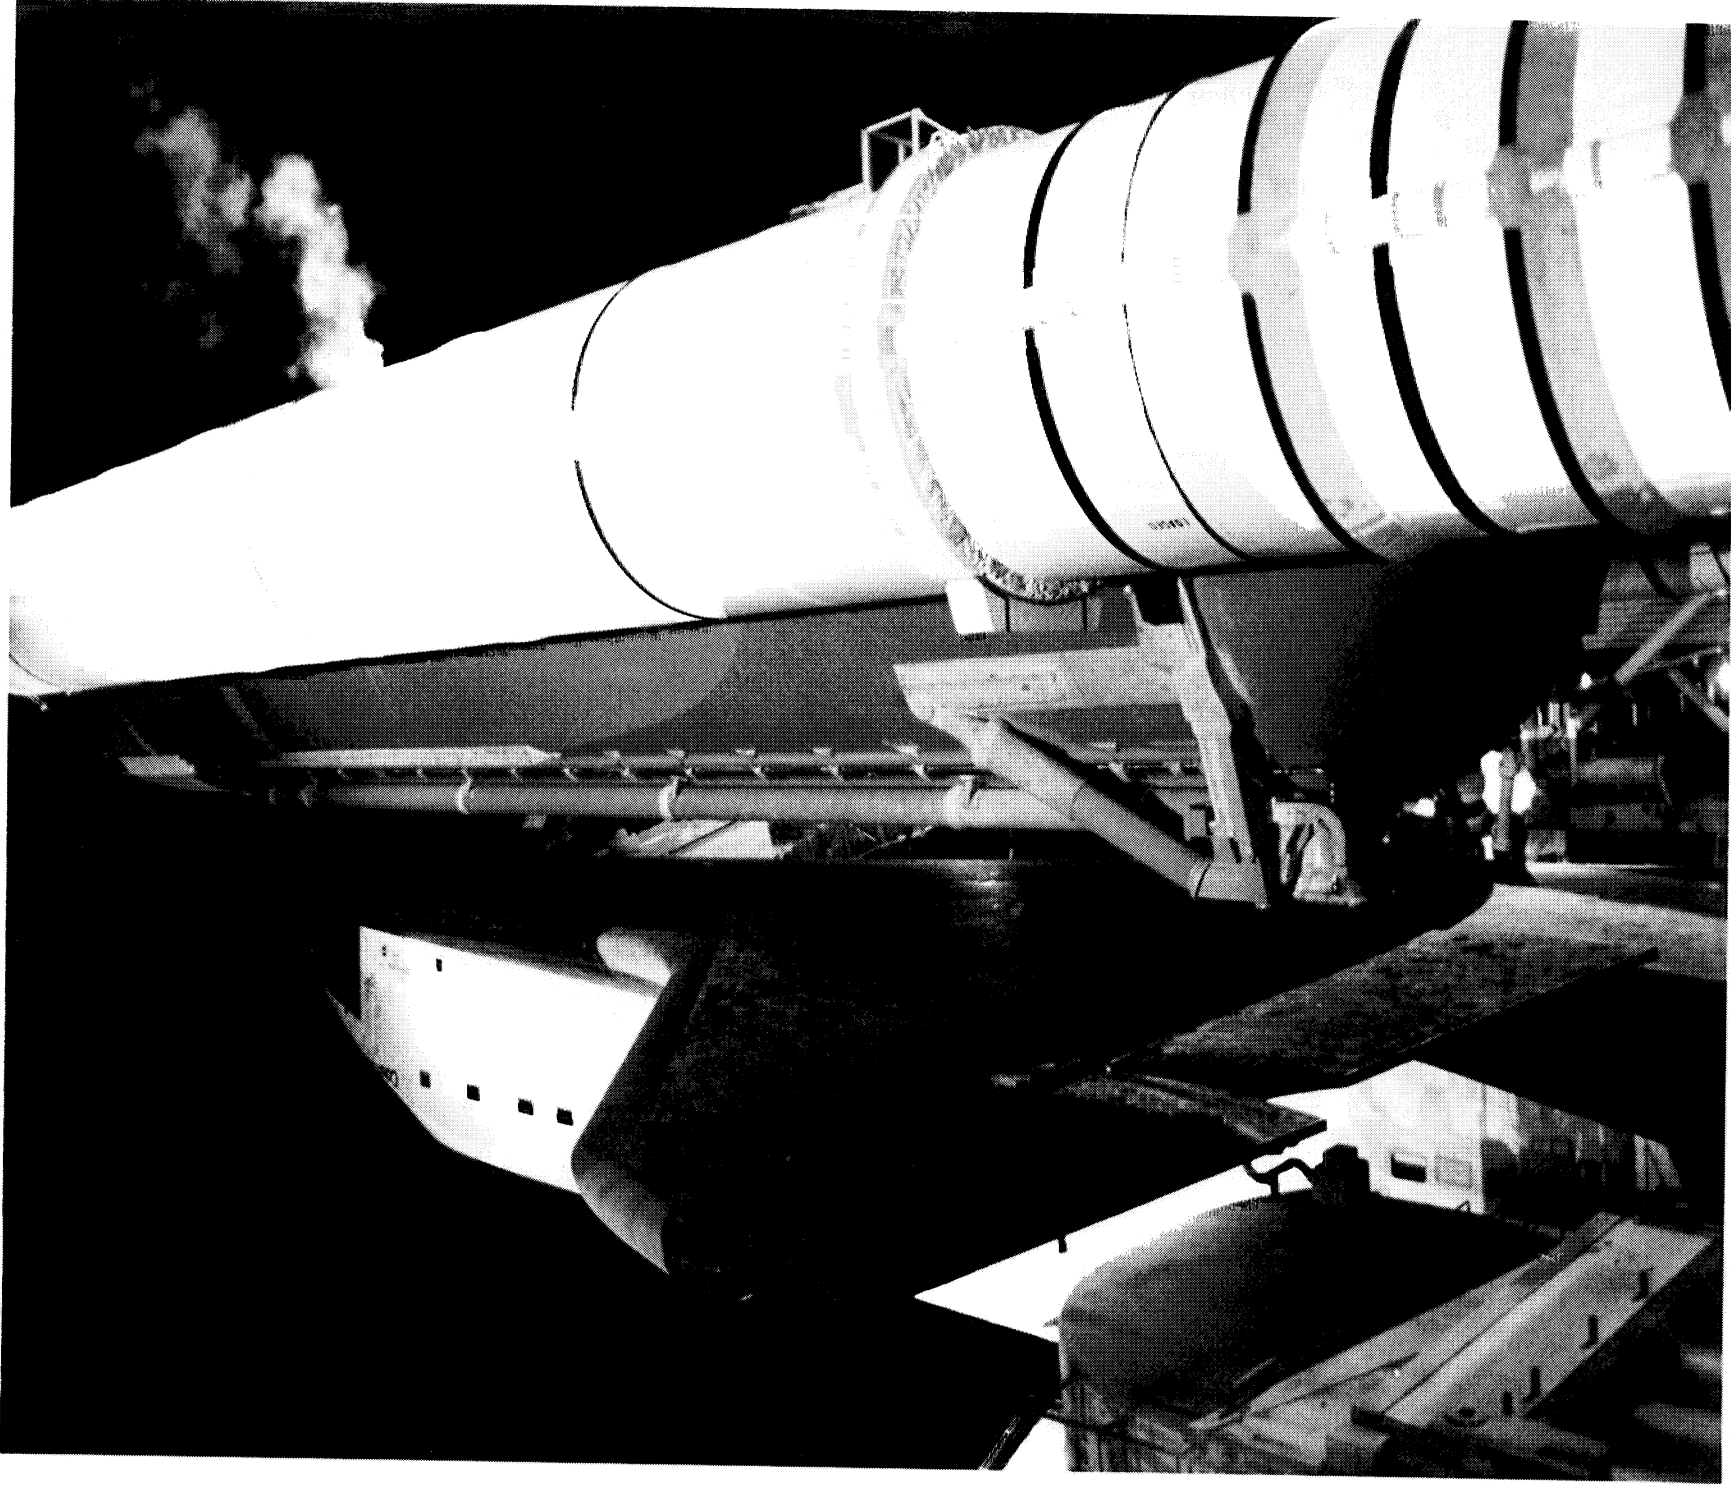
Overall view of the LH2 tank +Y+Z quadrant. Minimal ice/frost  
had formed on the ET/OPB LO2 umbilical.

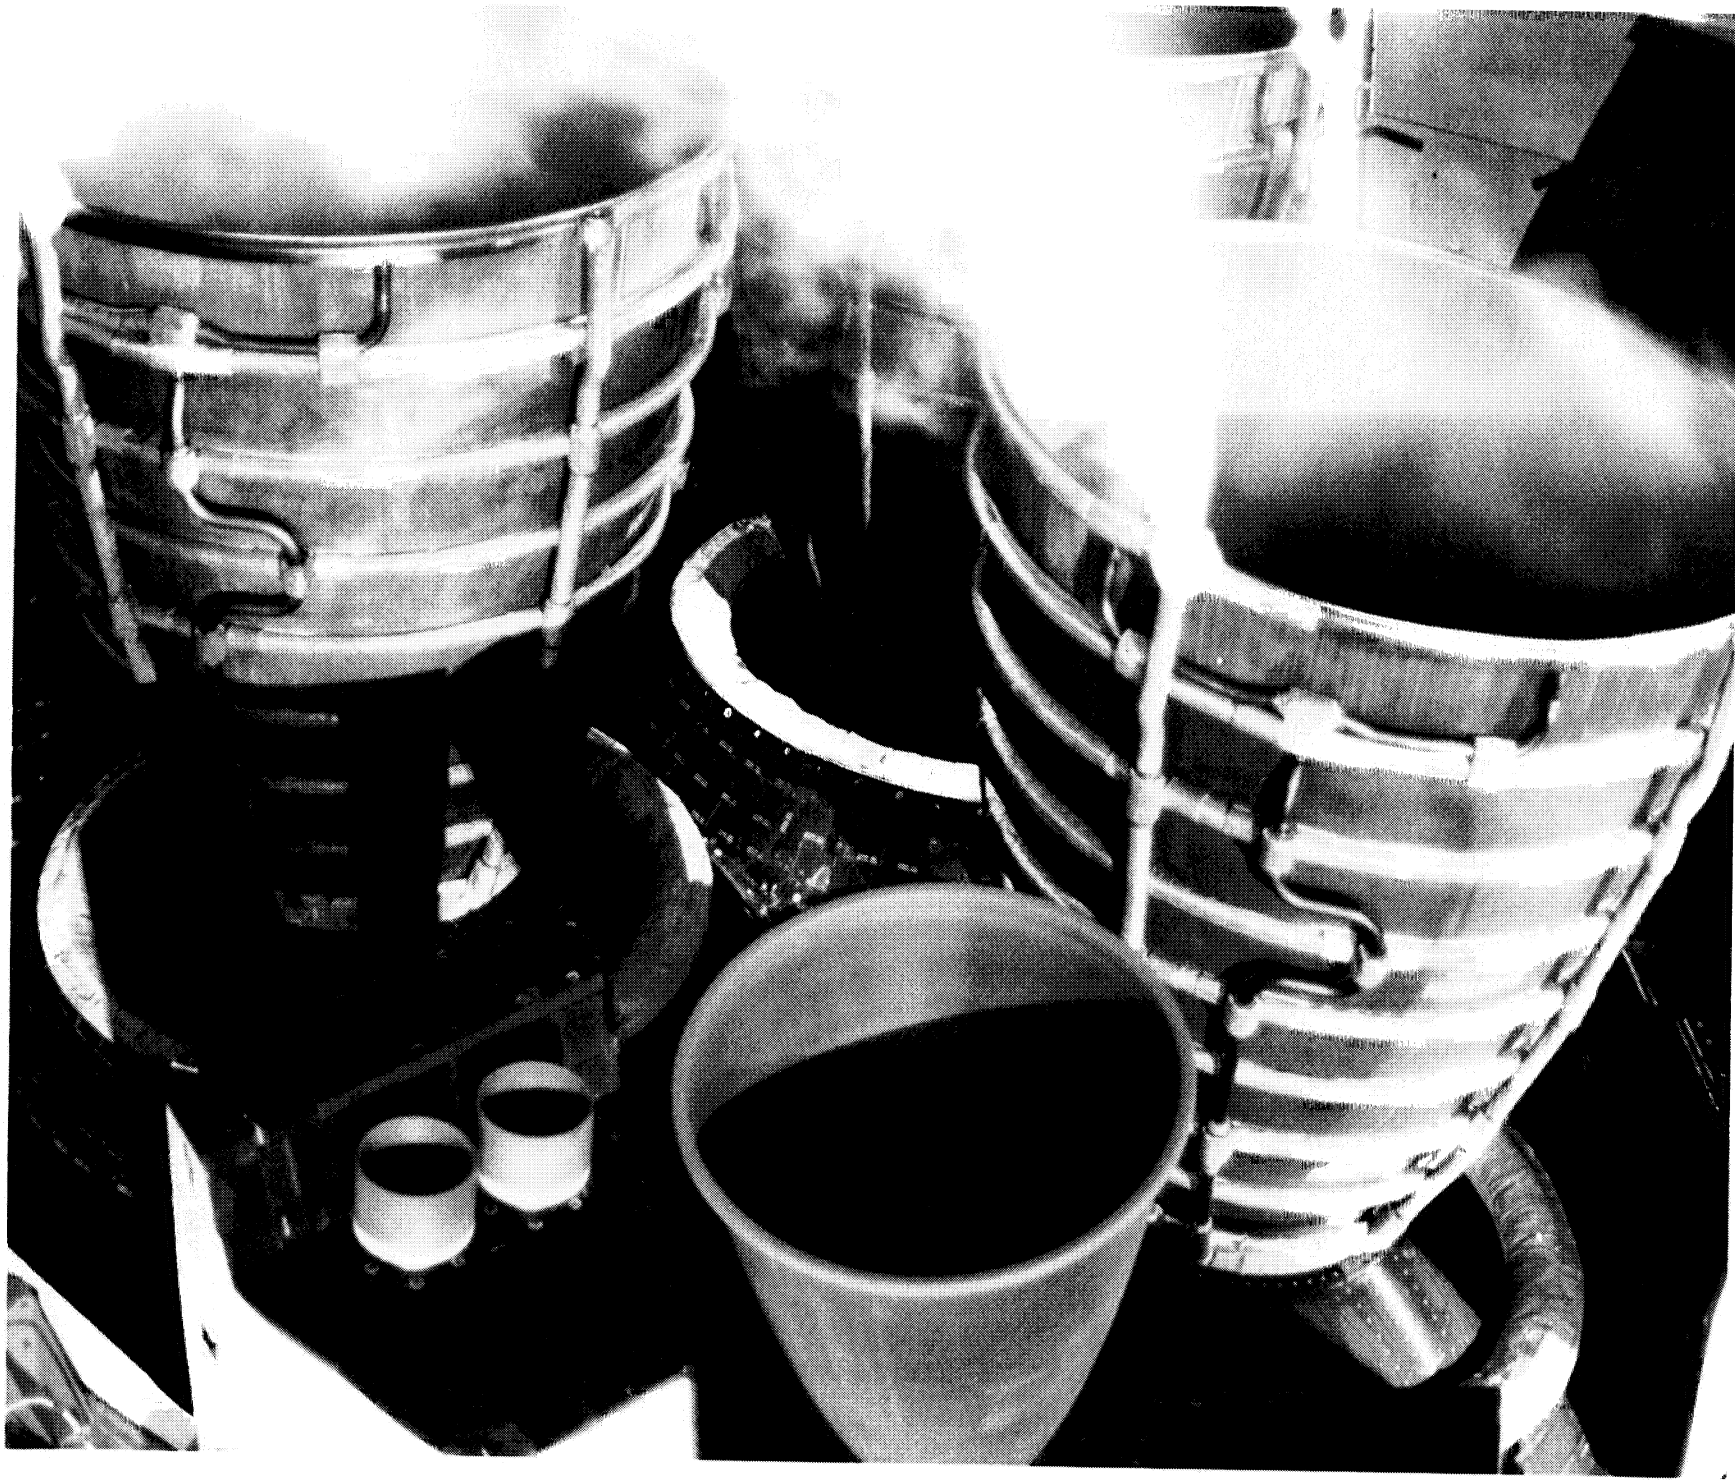
Overall view of SSME's. Note frost line on the engine mounted  
heat shield interface of SSME #2.

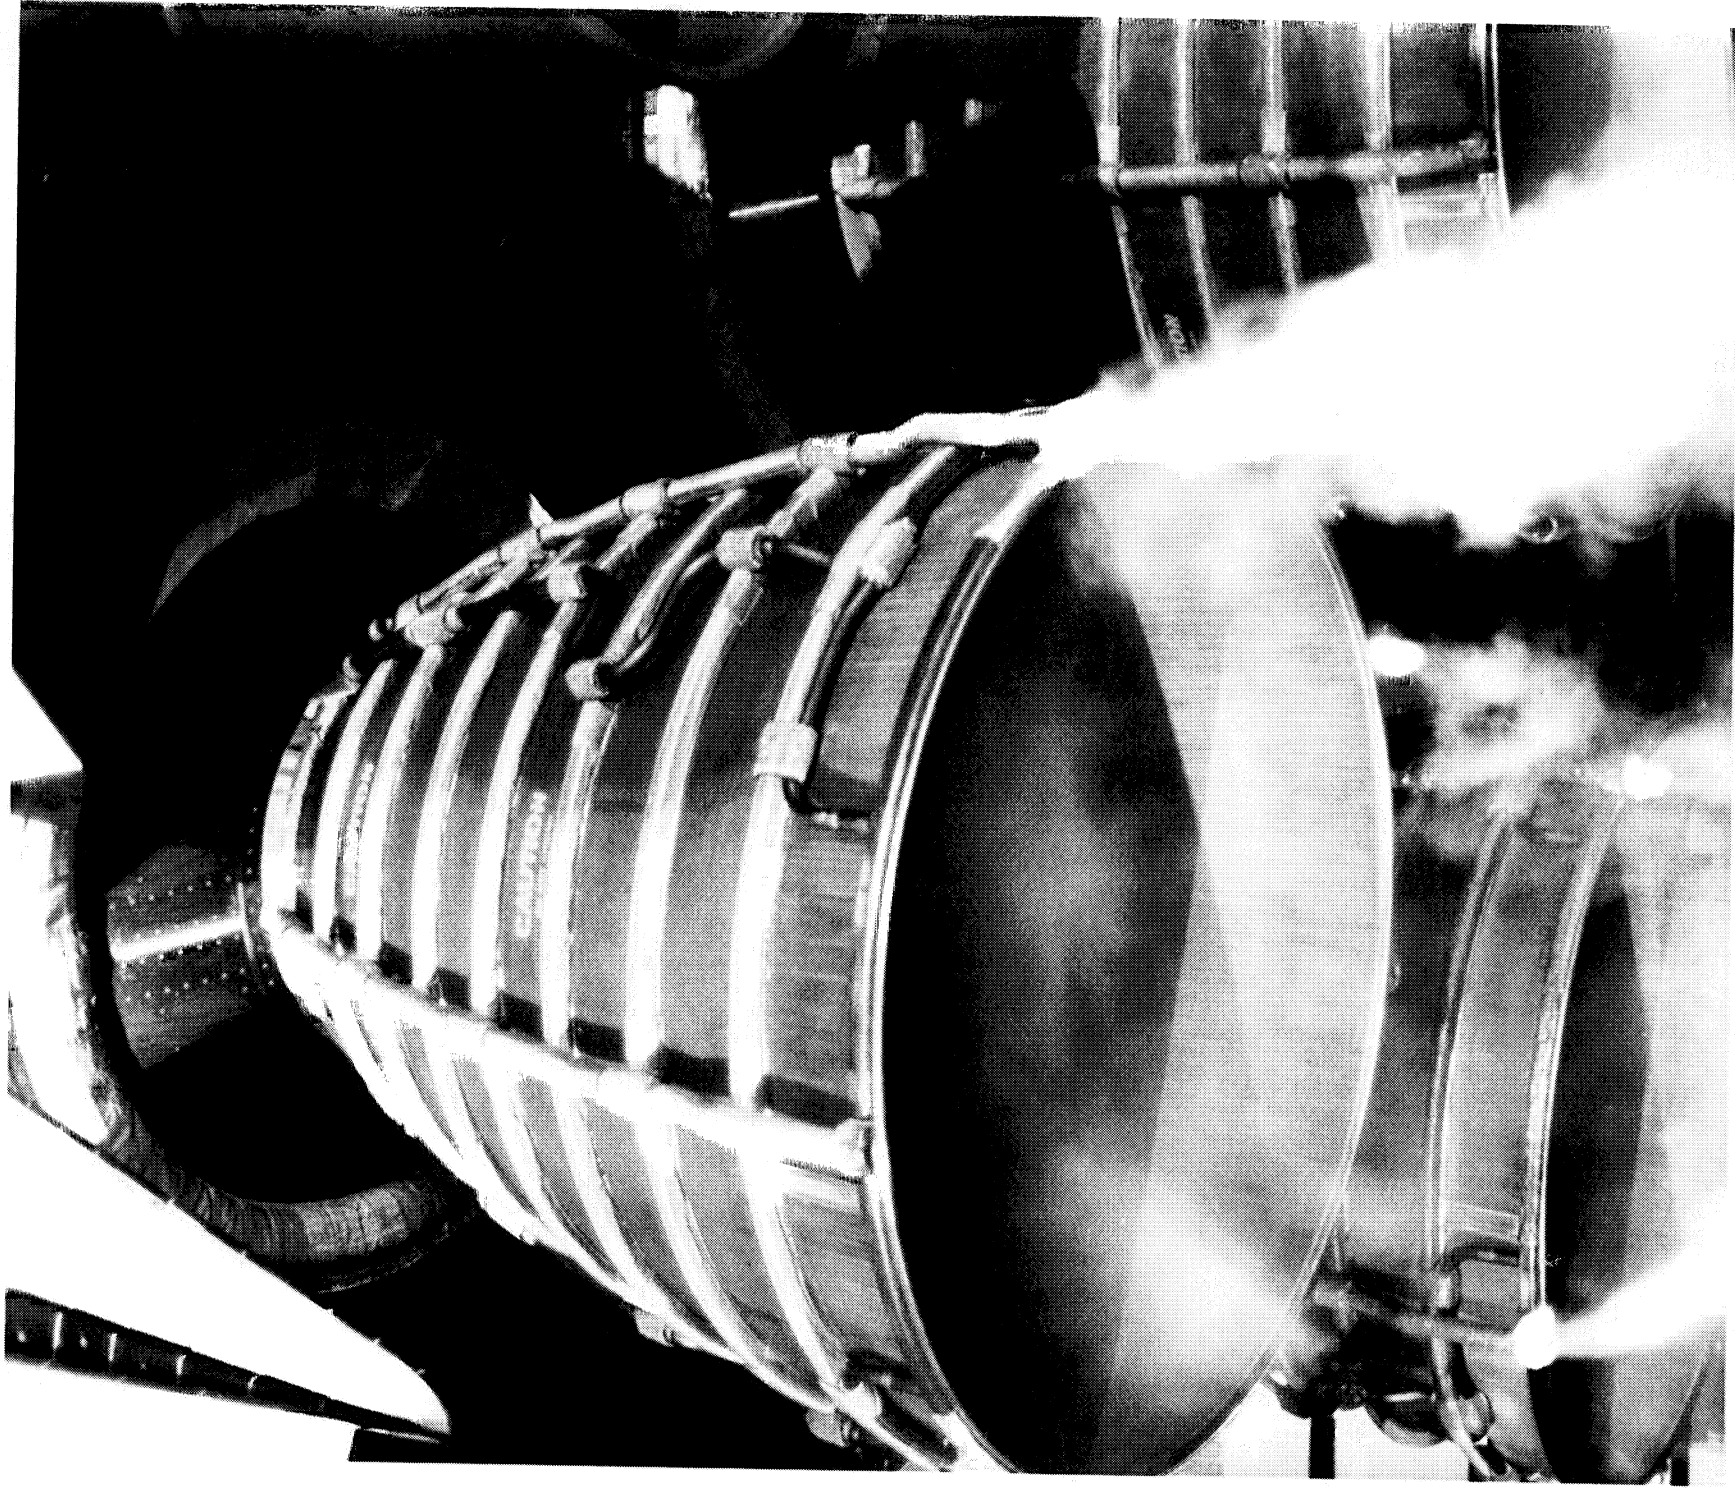
GOX vapors from the drain line are blown into the SSME nozzle by wind and may be misconstrued as a leaking SSME LO2 valve.

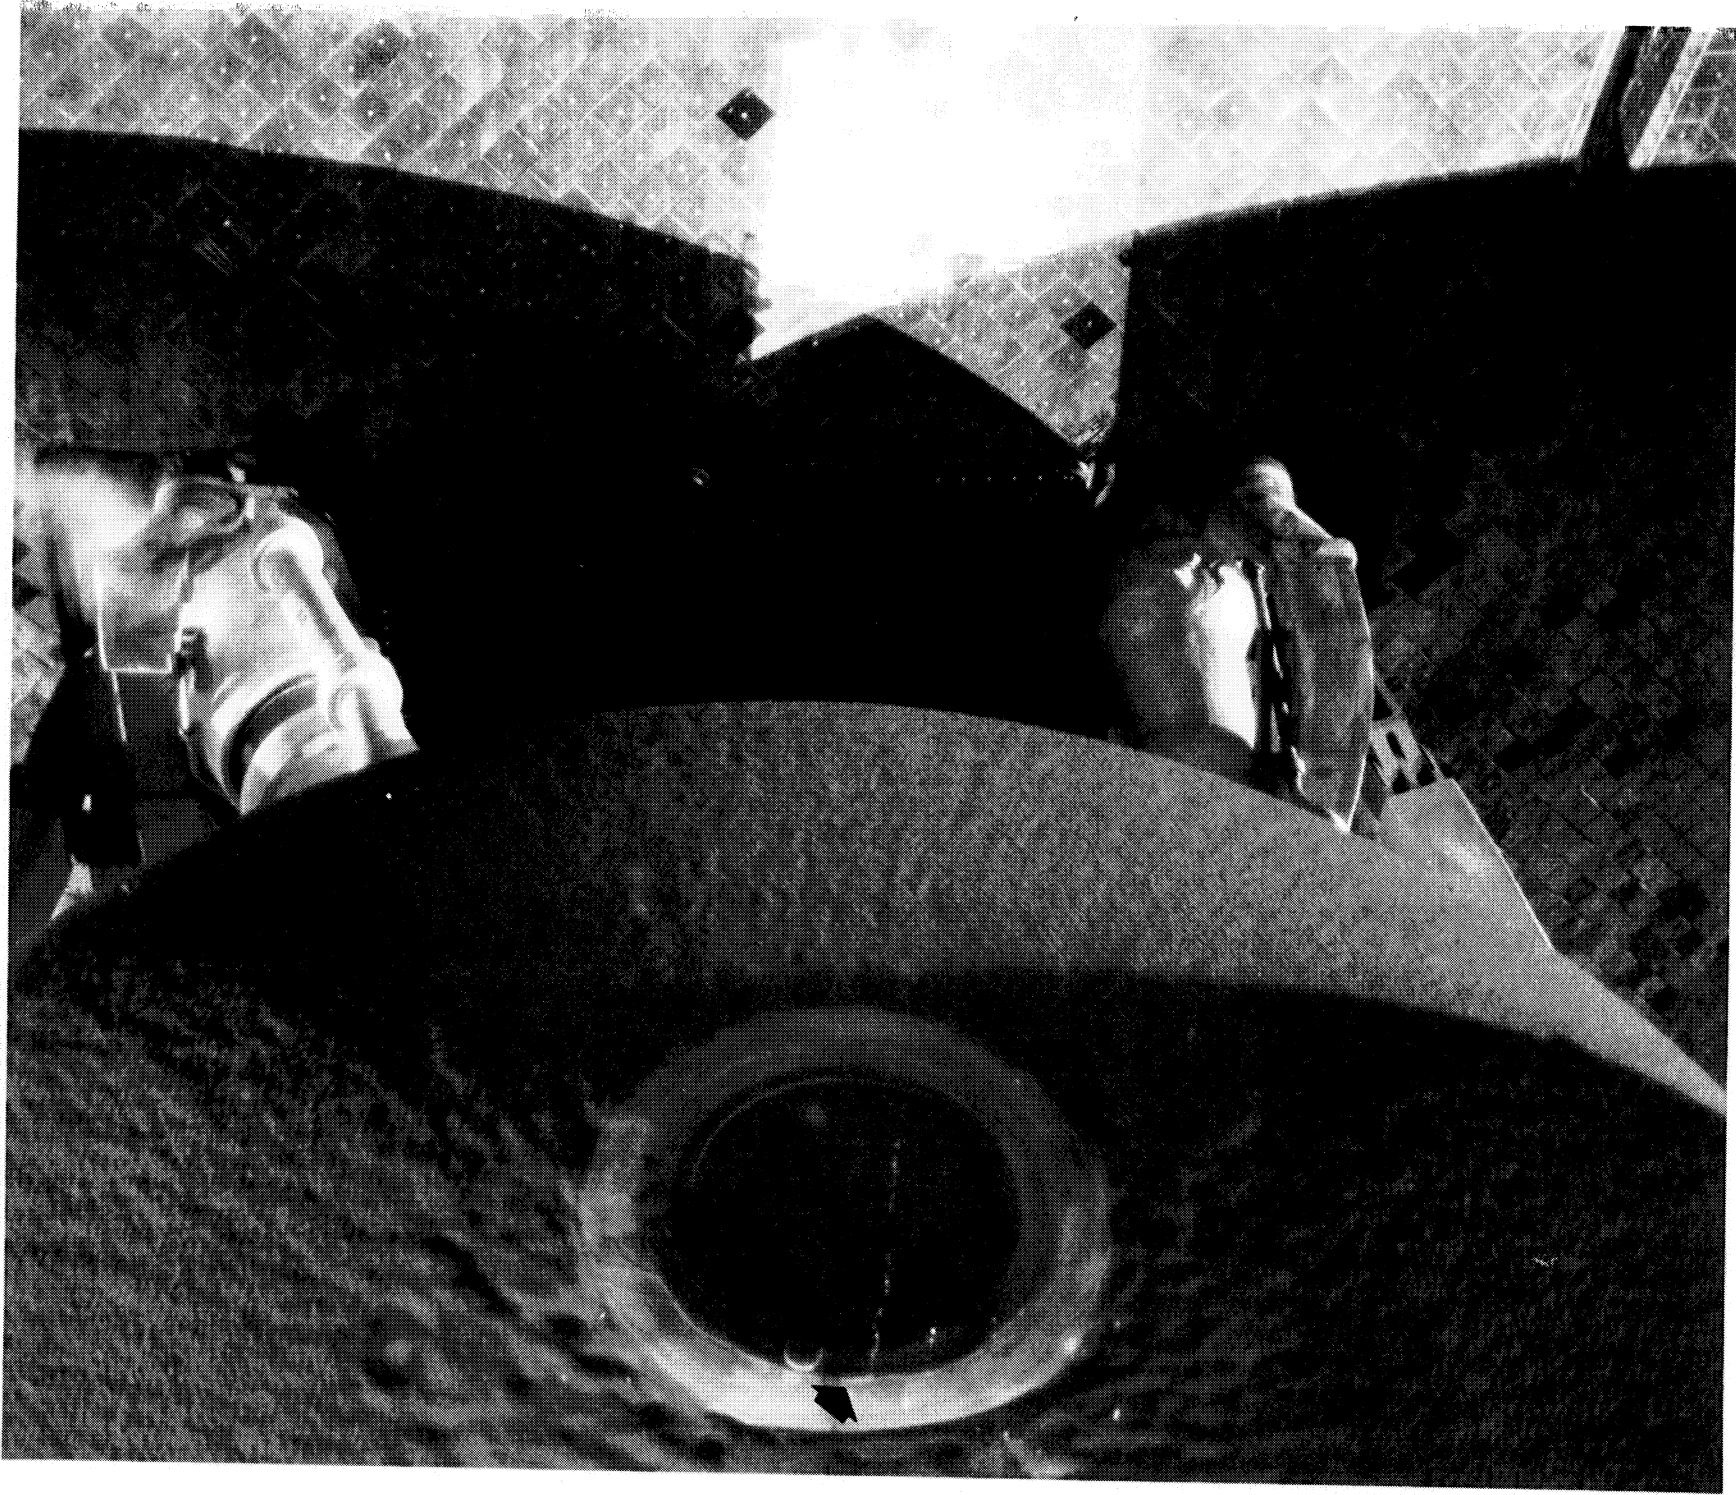
Ice formed on the aft side of the L02 umbilical. Ice is present in the LH2 recirc line bellows, but not in the feedline bellows. Note stream of condensate falling from the manhole cover (arrow).
